Birch Creek Watershed Action Plan

Confederated Tribes of the Umatilla Indian Reservation

Confederated Tribes of the Umatilla Indian
Reservation (CTUIR). 2016. Birch Creek
Watershed Action Plan. Oregon.

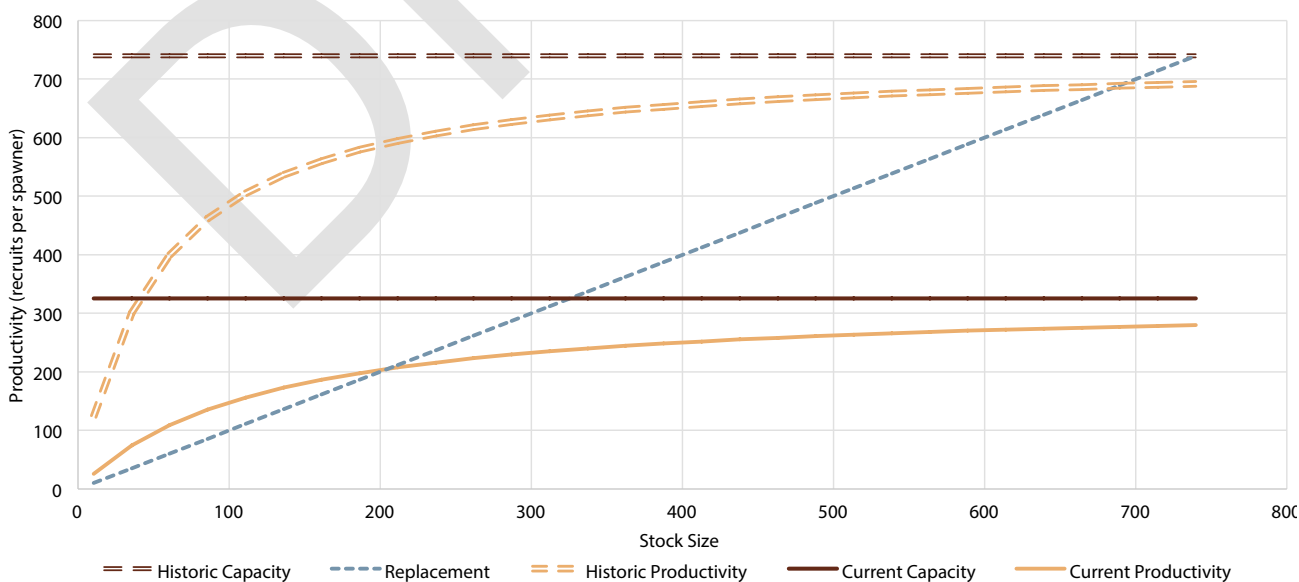
■ Figure 59. Stock recruitment relationships for the current and historic scenarios based on habitat productivity and capacity in West Birch Creek.
